GA357.24/GB/07/2022

Disassembly/assembly recommendations

<p>AUDI : SEAT : SKODA : VOLKSWAGEN</p>	<p>A3 série 2, A4 & A6 série 3 Cordoba IV, Ibiza III, Leon II, Altea, Altea XL Octavia I, fabia II Passat, Jetta III, Golf V plus, Polo IV</p>	<p>ENGINES 1.9TDI, 2.0TDi</p>	<p>OE REFERENCE <u>038903315AH</u></p>
--	--	---	--

IDENTIFICATION OF ACCESSORY BELT TENSIONER ROLLER GA357.24

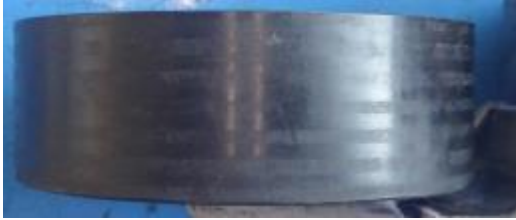
Pulley diameter erosion:

If the belt becomes incorrectly tensioned and moves on the pulley roller, and becomes misaligned. When this happens the polyamide part of the pulley becomes marked and damaged, in some cases the edge of the pulley wears. This wear may allow the belt to slide of the pulley in some situations.

Marks on the pulley

Damaged or worn GA357.24

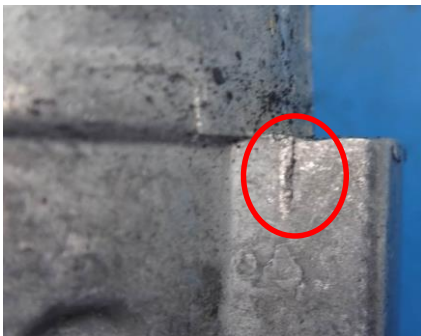
Tensioner GA357.04 is not designed to absorb the violent shocks caused by the bouncing and snatching of the belt. This bouncing and snatching motion prematurely wears the internal elements of the tensioner.

Marks on the stops show us the tensioner arm has been bouncing back and forth off the tensioner stops. When the tensioner is working correctly, the tensioner arm operates in between the two stops but never touches them.

Marks on the stop

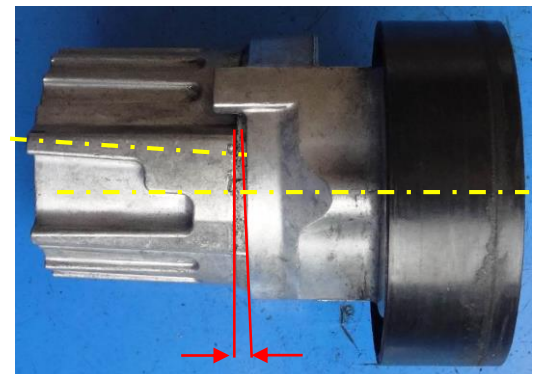
Worn central axis

A worn axis caused by belt misalignment, means the tensioner bends in the middle causing further belt misalignment.

Failures with GA357.24 are often caused by a faulty overrunning alternator pulley. Overrunning alternator pulleys should be checked or replaced at the same time as the tensioner roller assembly is replaced.
