# KB659.26

## Assembly recommendations

<p><b>Citroën:</b> Jumper (I, II, III), Relay (II, III)  <b>Fiat:</b> Ducato (I, II)  <b>Peugeot:</b> Boxer (I, II, III)</p>	<p><b>OE Reference:</b>          1610531680          5031-78          9405031789</p>
--	--

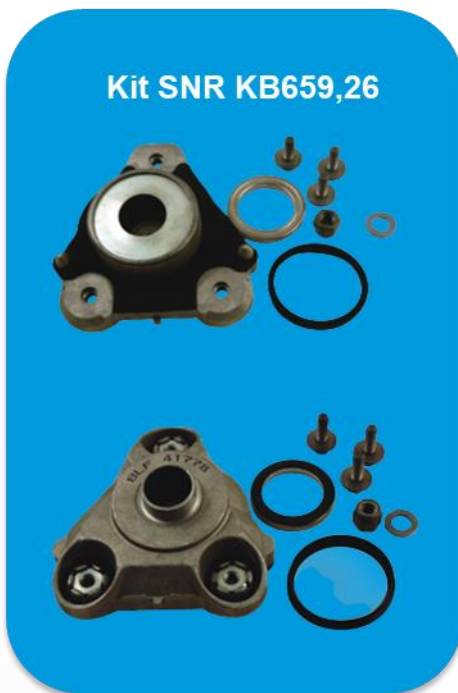
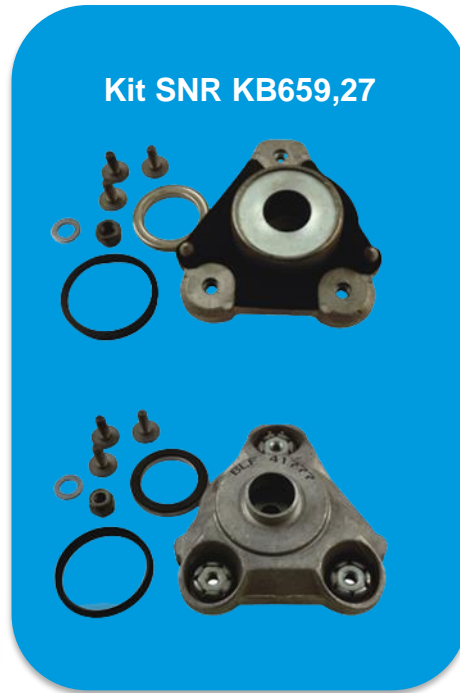
PREMATURE FAILURE OF THE STOP

**Improper installation of the kit.**

Failure is linked to some kind of pollution being introduced; it is important to change all the parts and especially to follow the reassembly instructions correctly. This failure is a result of an inverse assembly of the two stops and two joints (see assembly process).

- Observe the direction of the stop: dark side of the stop to the filter block side.
- Observe the direction of the seal: sealing lip on the filter block side.
- Careful not to deform the joints during assembly and do not overly lubricate the two sets.
