DPF350.01

Assembly/disassembly recommendations

BMW:	Series 1 (E87), Series 3 (E46/E90/E91/E92/E93), Series 5 (E60/E61), Series 5 LCI (E60/E61), X3 (E83), X3 LCI (E83)	ENGINES	OE reference
		2.0 D, 2.0TD	11 23 7 805 696, 11 23 7 801 977, 11 23 7 793 882

IDENTIFICATION OF DAMPER PULLEY DPF350.01

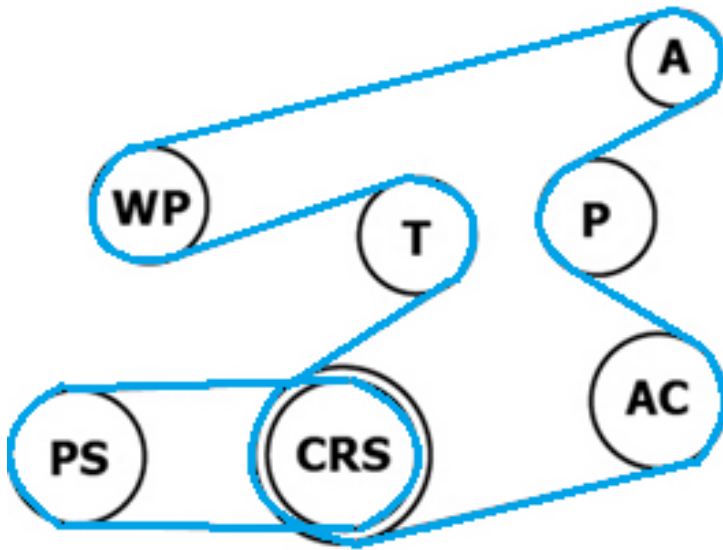
A	Alternator	P	Return pulley
AC	Air-conditioning compressor	PS	Power steering
CRS	Crankshaft	T	Tensioner roller
		WP	Coolant pump

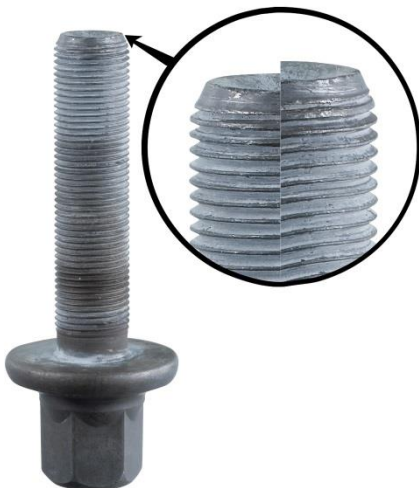
Bolt deformation

The dimensions of a new retaining bolt are **M18 x 1.5** with a maximum length of **85.5 mm**. It is essential to use a washer with this bolt.

During torque angle tightening, the bolt will become deformed and stretched. It is therefore recommended that a new retaining bolt is used when either a new or old pulley is fitted. Failure to do so can result in the pulley not being tightened correctly, allowing it to spin on the crank.

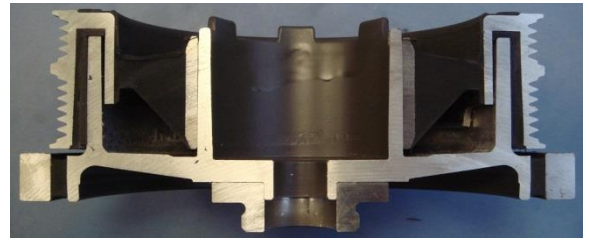
Composition

This crankshaft pulley is comprised of an outer aluminium pulley attached to an inner hub with an elastomeric (rubber) element sandwiched between them.

Sometimes a small amount of grease leakage can be seen from the rear plate of the pulley. This does not effect the correct operation of the pulley.

This pulley is made of aluminium, this means that it is very fragile, impact damage may cause the pulley to become unsuitable for use.

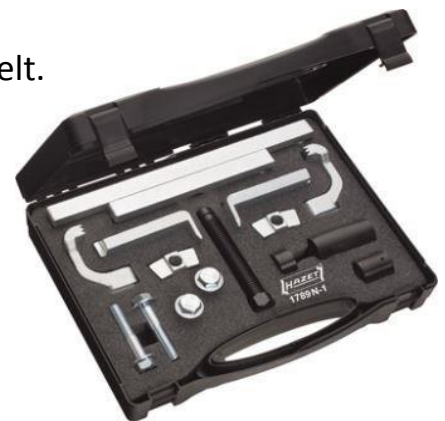
- Torque wrench and torque-angle spanner
- HAZET tool set: (pulley extractor)
Ref.1789N-1 for pulley removal

- 1) Remove the accessory belt
- 2) Remove the old crankshaft pulley
Use a HAZET extractor.
- 3) Clean any debris and dirt from around the crankshaft area
