GA357.24/GB/07/2022

Disassembly/assembly recommendations

<p>AUDI : SEAT : SKODA : VOLKSWAGEN</p>	<p>A3 série 2, A4 & A6 série 3 Cordoba IV, Ibiza III, Leon II, Altea, Altea XL Octavia I, fabia II Passat, Jetta III, Golf V plus, Polo IV</p>	<p>ENGINES 1.9TDI, 2.0TDi</p>	<p>OE REFERENCE <u>038903315AH</u></p>
--	--	---	--

IDENTIFICATION OF ACCESSORY BELT TENSIONER ROLLER GA357.24

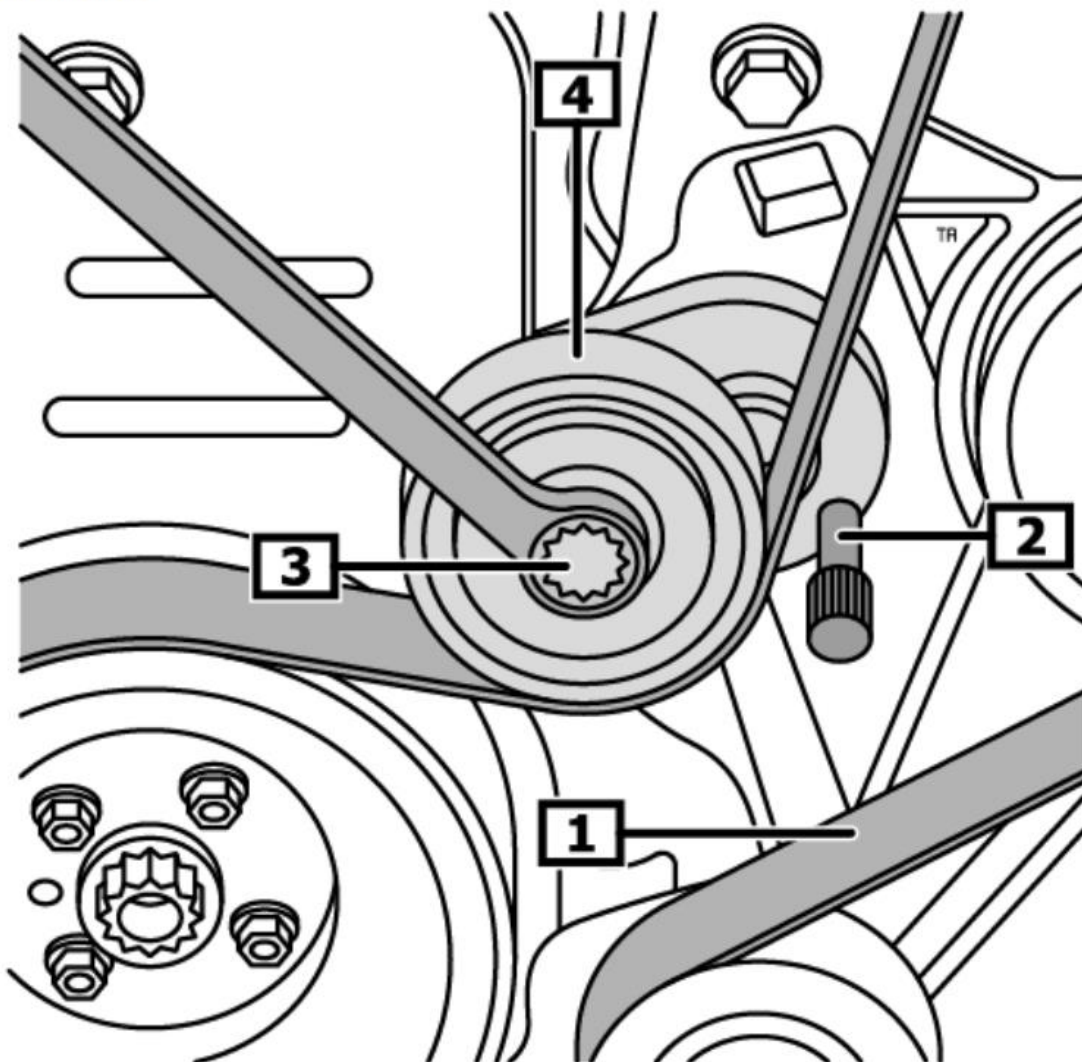
Illustration 2

1 Auxiliary belt

2 Locking pin

4- Remove the locking pin and gently let the tensioner return to the rest position
